Explosives Safety Bulletin

March 2010

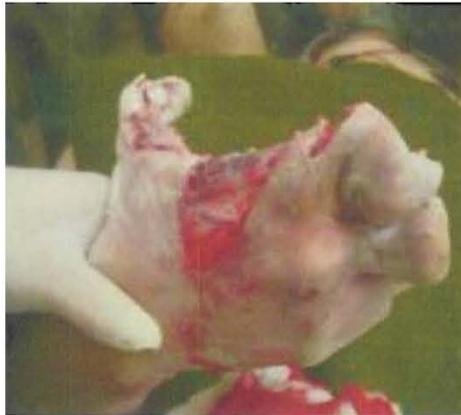
Misidentifying or treating the FOG as a standard smoke grenade can have serious safety consequences. The Army has had two serious accidents recently causing permanent partial disability to soldiers. The first involved a soldier who was simulating an improvised explosive device during training mistakenly used a FOG for this purpose, rather than a standard smoke grenade with a longer delay. The soldier pulled the pin on the grenade and released the

safety lever, but continued to hold the grenade. After one second, the FOG functioned in the soldier's hand, resulting in the loss of two fingers, as well as burns and minor shrapnel wounds. The second accident involved a Soldier training with the FOG grenade, which functioned in soldier's right hand before soldier was able to release it. Soldier sustained a fracture injury to the palm, and amputation of index, middle, and ring fingers.

- All FOG grenades will be turned in to the supporting ASP
- All units will inspect on-hand munitions to determine if FOG grenades are present
- FOG grenades will be secured from other smoke grenades and turned in to ASP
- Units that have an operational need for the FOG will conduct and document training on the deployment and differences between FOG and regular smoke grenades prior to reissuance of FOGs.

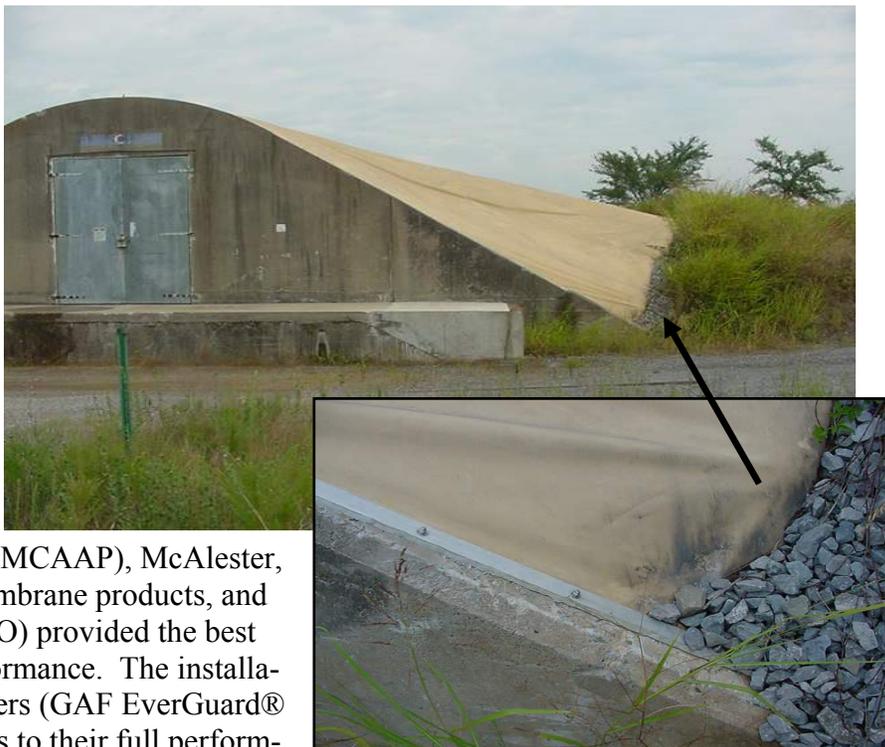
The durability and protective effectiveness of earth-covered magazines (ECMs) are adversely affected by the use of expansive soils in the earth cover. Such soils swell or contract depending on the amount of moisture present in them, compromising the cover's integrity. The need for magazine maintenance that results from this process can be minimized by the installation of a single-ply water-proofing membrane over the earth cover.

McAlester Army Ammunition Plant (MCAAP), McAlester, Oklahoma, tested several single-ply membrane products, and found that thermoplastic polyolefin (TPO) provided the best combination of characteristics and performance. The installation of one particular brand of TPO covers (GAF EverGuard® TSR-60) at MCAAP returned magazines to their full performance by stopping interior water leakage; stabilizing earth-cover moisture content through the removal of structural stress loads resulting from the expansion and contraction of clay soils; eradicating vegetation on the tops of magazines, with a consequent elimination of mowing requirements; providing excellent fire resistance; and preventing losses of earth cover as a result of heavy rains.

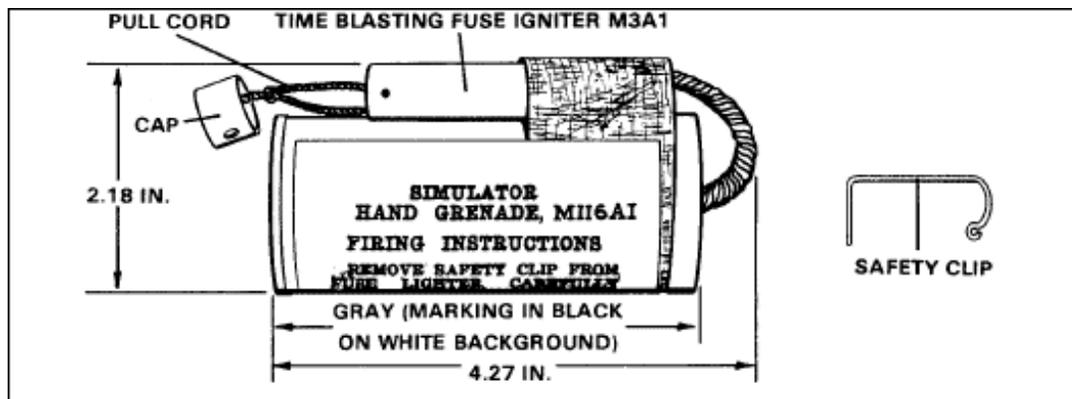
A Soldier found a hand grenade simulator mixed in with recovered residue and dunnage that was being transported to an administrative supply building for further processing. The simulator was crushed, but its pull string was still present. Because of the simulator’s crushed condition, the Soldier apparently believed that it no longer posed an explosive hazard. The Soldier then removed the pull string from the simulator for accountability purposes, whereupon the simulator functioned with little or no delay time, causing loss of part of the Soldier’s right hand, as well as lacerations and burns to the Soldier’s face and side. A second Soldier who was nearby sustained a ruptured ear drum, and eleven other Soldiers experienced ringing in their ears.

Until any explosive item has been verified as fully expended, or has undergone a demilitarization process that has certified it as explosive-free, a potential hazard is always present. Personnel coming in contact with ammunition items that still pose an explosive risk (even if they are apparently unserviceable for their intended use) must treat them with the same caution and respect given to undamaged, unexpended materiel. In fact, the need for hazard awareness and safe handling practices applies even more to visibly damaged items, since their condition may have compromised built-in safety features (such as delay times), and made them even more dangerous than they would normally be.

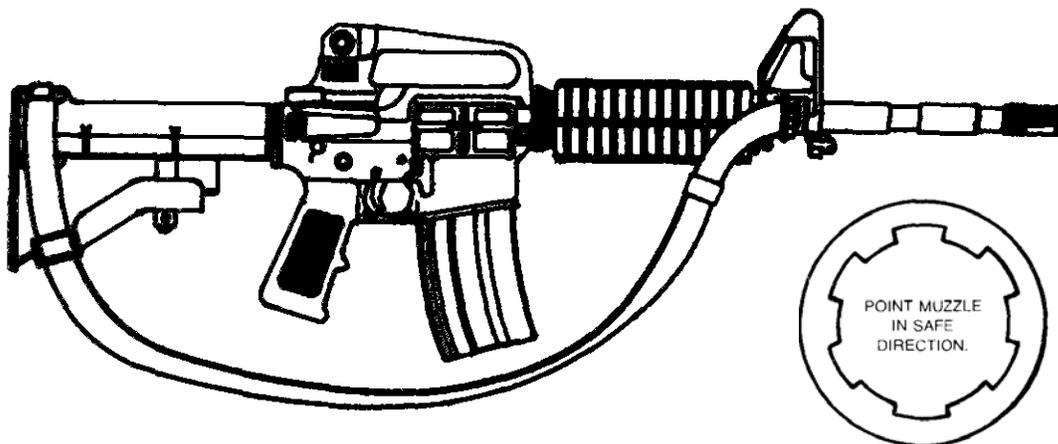
A Soldier was firing an M4 5.56mm Carbine for the first time. When the Soldier pulled the trigger, the weapon exploded, resulting in lacerations to the Soldier's upper lip and gum. Examination of the weapon revealed that residue from previously-expended training rounds was still present in the barrel.

Two fundamental user errors contributed to this mishap. The first was non-inspection of the weapon before firing, and the second was the Soldier's failure to clean the weapon bore before assuming a position on the firing line. These actions are basic principles of safe weapon use, and are routine components of both weapon technical manuals (such as TM 9-1005-319-10), and range standing operating procedures.
