Adverse Effect to the Childers House on the Fort Campbell Army Installation

Childers House, Building 6081

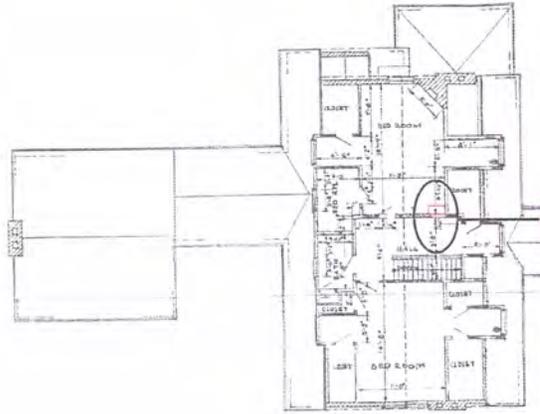
drywall added to hide new
HVAC
